Contract #: 04-0120F4Cty: SF/ALA Rte: 80 PM: 13.2/13.9File #: 69.28**WELDING INSPECTION REPORT****Resident Engineer:**Siegenthaler, Peter**Address:** 333 Burma Road**City:** Oakland, CA 94607**Report No:** WIR-022070**Date Inspected:** 22-Mar-2011**Project Name:** SAS Superstructure**OSM Arrival Time:** 700**Prime Contractor:** American Bridge/Fluor Enterprises, a JV**OSM Departure Time:** 1900**Contractor:** Zhenhua Port Machinery Company, Ltd (ZPMC), Changxing Island **Location:** Shanghai, China**CWI Name:** An Qing Xiang**CWI Present:** Yes No**Inspected CWI report:** Yes No N/A**Rod Oven in Use:** Yes No N/A**Electrode to specification:** Yes No N/A**Weld Procedures Followed:** Yes No N/A**Qualified Welders:** Yes No N/A**Verified Joint Fit-up:** Yes No N/A**Approved Drawings:** Yes No N/A**Approved WPS:** Yes No N/A**Delayed / Cancelled:** Yes No N/A**Bridge No:** 34-0006**Component:** OBG**Summary of Items Observed:**

BAY 14, OBG 13BW (NWIT # 08592)

WELDING INSPECTION REPORT

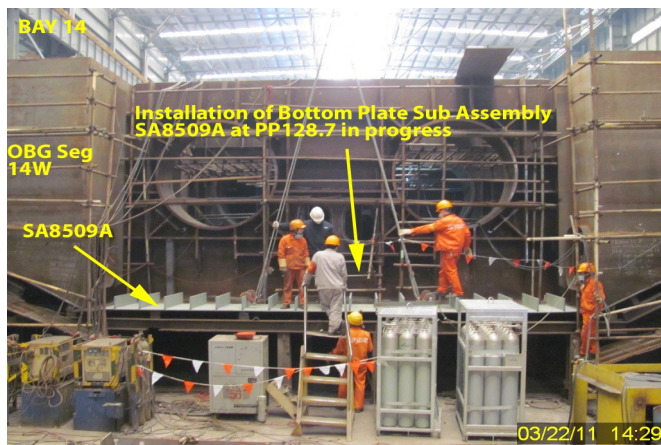
During random in process inspection this QA inspector observed the installation of Bottom Plate Sub Assembly SA8509A at Panel Point 128.7 of segment 14W. See attached photographs for more details.

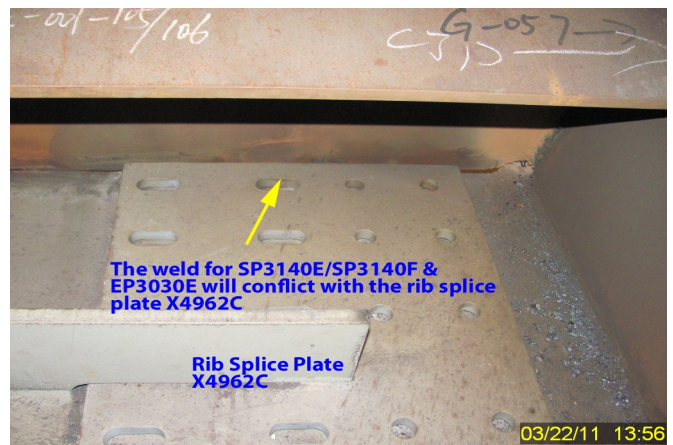
During random in process inspection this QA inspector observed that for OBG Ifit 14 PP128~PP128.3, since the weld for SP3140E/SP3140F & EP3030E will conflict with the rib splice plate X4962C, and there will be about 600mm length cannot be weld. This issue has been discussed with ZPMC CWI Mr. An Qing Xiang, AB/F QA Mr. Xiao Jun Peng and CT Lead QA. ZPMC CWI Mr. An Qing Xiang informed this QA that this issue would be solved in manner compliant with contract documents. See attached photographs for more details.
